FATIGUE BEHAVIOR OF A CROSS-PLY
CERAMIC MATRIX COMPOSITE UNDER TENSION-
TENSION AND TENSION-COMPRESSION LOADING

THESIS

Presented to the Faculty of the School of Engineering
of the Air Force Institute of Technology
Air University
In Partial Fulfillment of the
Requirements for the Degree of
Master of Science in Aeronautical Engineering

December 1992

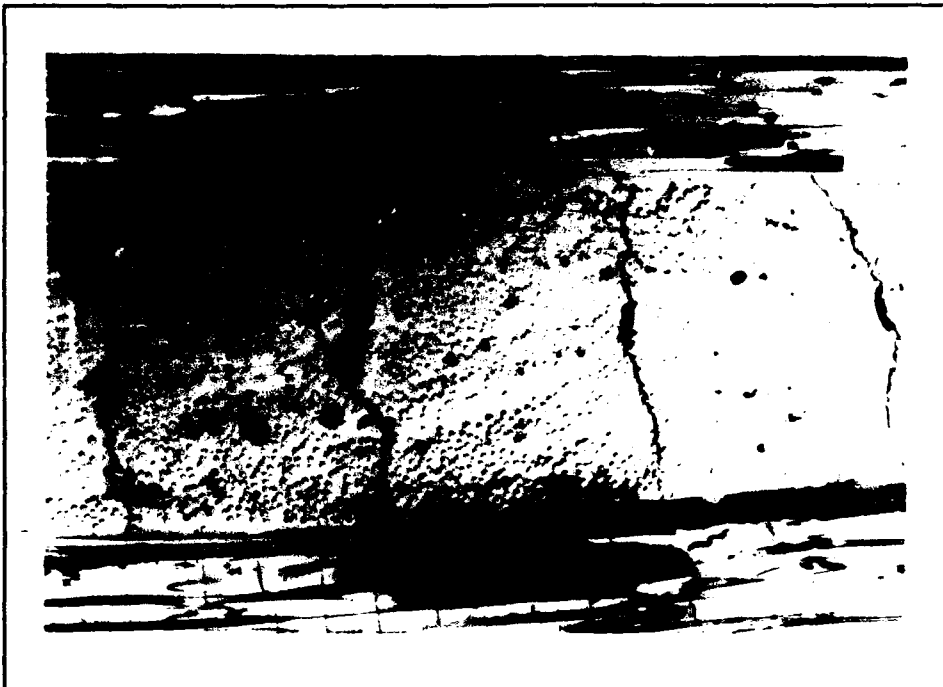
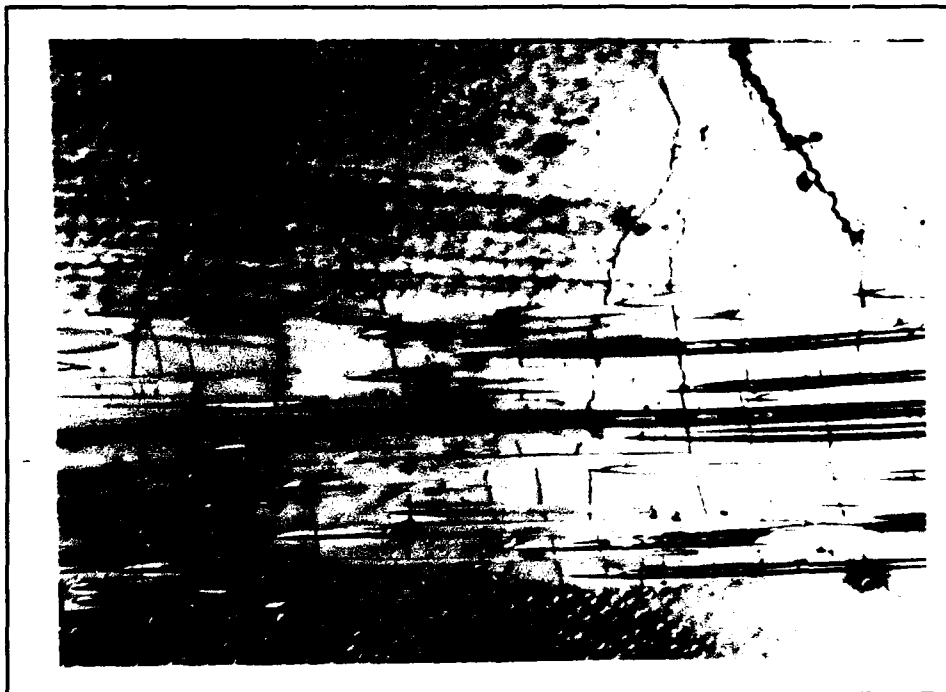
Figure 7
(Static Tension Test, 75 MPa, 50X)

Figure 8
(Static Tension Test, 125 MPa, 50X)

Figure 9
(Static Tension Test, 175 MPa, 50X)

Figure 10
(Static Tension Test, 250 MPa, 50X)

Figure 11
(Static Tension Test, 250 MPa, 100X)

Since the degradation of the modulus occurred in a similar fashion in each test and in comparable magnitudes, the reason for two to fail and not the third must be explained. Figures 7 through 11 show the crack

progression in a static tension test. At 50 MPa, 90° matrix cracking has begun. Since all three tension-tension tests surpassed this value, this cracking obviously occurred in all three specimens. However, the difference between the damage in each becomes more evident at 150 MPa. Above this value, those transverse cracks begin bifurcating and severely increasing in the 0° plies. According to Zawada [15], even with transverse cracks, the matrix in both the 0° and 90° plies still supports a portion of the load. At some point, however, a stress re-distribution occurs in which the matrix becomes unable to support any additional load and the entire stress is transferred to the fibers. Since the load is now distributed over a "smaller" area, the stress is theoretically increased and fiber breakage ultimately occurs. The 150 MPa value is the limit in which the matrix can support a load below that value but eventually fails above it. It is for this reason that tension-tension tests at 160 and 180 MPa failed but the test at 140 MPa achieved cycle runout. Figure 33 shows the fracture surface of the 160 MPa tension-tension specimen.

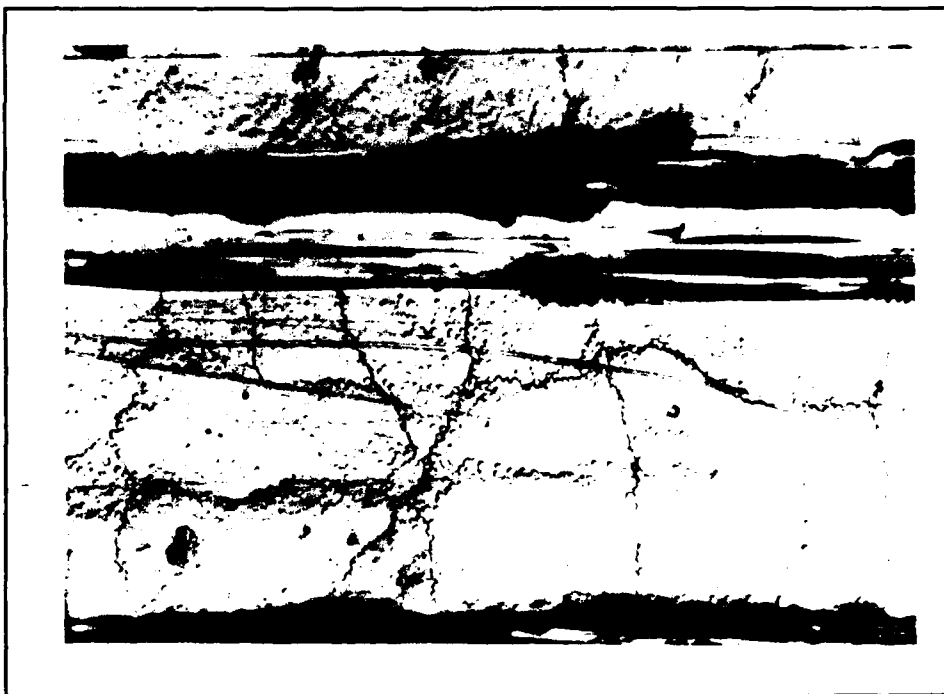
A second test was then run with replicas. Just like in the tension-tension tests, significant damage occurred during the first cycle with the development of transverse cracks spanning the entire width of the specimen. By 50,000 cycles, these cracks had started bifurcating with the crack density increasing. At approximately 450,000 cycles, however, longitudinal cracks formed in the middle 90° plies. Within the next few hundred thousand cycles, these longitudinal cracks began interacting with the transverse ones, causing an increase in the transverse cracks and

lengthening the longitudinal ones. By 1,000,000 cycles, additional longitudinal cracks had formed in the middle and outer 90° plies and ran the entire length of the specimen. This crack development is shown in Figures 22 through 25. While it should be noted that cycle runout did occur, it's clearly evident that significant damage had been sustained. Had 1,000,000 cycles not been chosen as a stopping point, in all likelihood, the damage shown at 1,000,000 cycles appeared to have been progressing and failure could have occurred had the test been allowed to continue.

Figure 22
(140 MPa Tension-Compression Test, R = -1.0, Cycle 1, 50X)

Figure 23
(140 MPa Tension-Compression Test, $R = -1.0$,
Cycle 50,000, 50X)

Figure 24
(140 MPa Tension-Compression Test, $R = -1.0$,
Cycle 700,000, 50X)

Figure 25
(140 MPa Tension-Compression Test, $R = -1.0$,
Cycle 1,000,000, 50X)

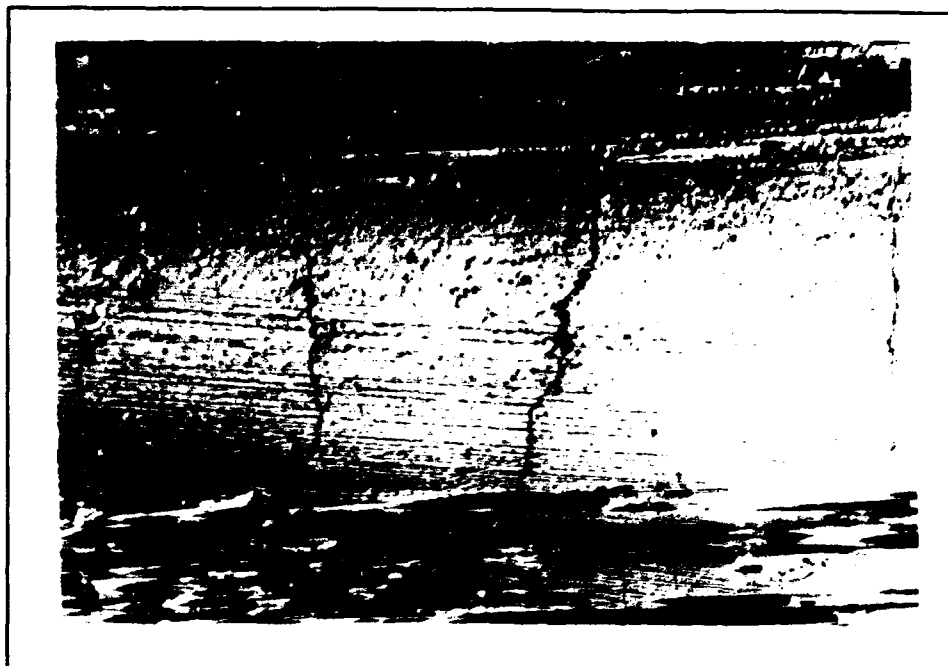
Three tension-compression tests at a load ratio of -1.5 were then run. All three failed in compression. Figure 26 shows the stress-strain curve for the second test while Figure 27 shows its normalized modulus versus cycles. The third test was then run with replicas taken. Cracks developed in the same manner as in the tension-compression test at a load ratio of -1.0 , but the time at which they occurred was much sooner. Transverse cracks developed within the first cycle, then crack bifurcation started by 10,000 cycles. Longitudinal cracks formed around 175,000 cycles, followed by crack interaction, crack lengthening, and then failure at 350,330 cycles. Figures 28 through 31 show the crack development.

Figure 28
(140 MPa Tension-Compression Test, R = -1.5,
Cycle 1, 50X)

Figure 29
(140 MPa Tension-Compression Test, $R = -1.5$,
Cycle 10,000, 50X)

Figure 30
(140 MPa Tension-Compression Test, $R = -1.5$,
Cycle 250,000, 50X)

Figure 31
(140 MPa Tension-Compression Test, $R = -1.5$,
Cycle 350,000, 50X)
